Granby Street Conservation Area Character Appraisal

Planning Policy and Design
Adopted March 2007

GRANBY STREET CONSERVATION AREA

character appraisal

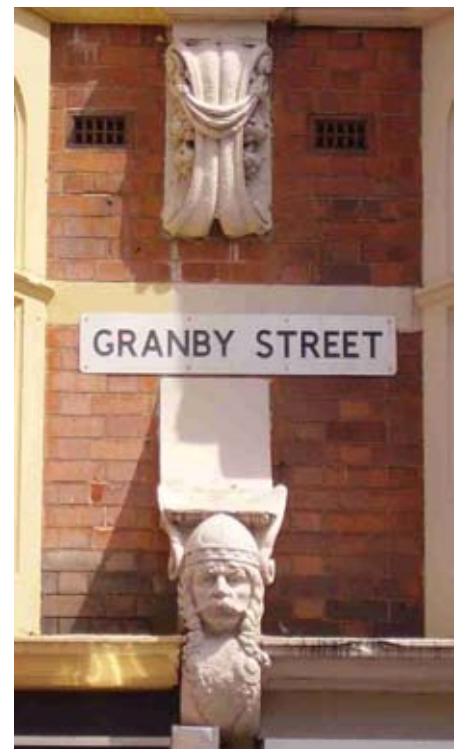
A close up of the bearded Viking figure-head to 68-74 Granby Street.

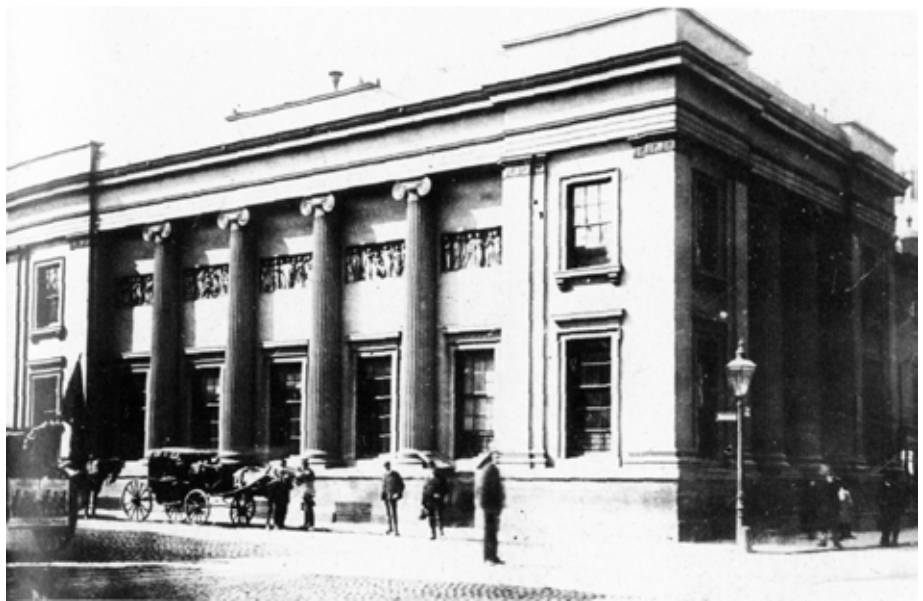
A view of William Flint's General News Room of 1838, this was certainly Flint's finest building but was unfortunately lost when Granby Street was widened in 1897/8.

4.9 In 1897/8 Granby Street was widened again and several buildings date from that time, such as the elaborately decorated stone-built News Room at the corner of Belvoir Street. This replaced what may have been the finest building by local architect, William Flint, the Greek revival 'General News Room' of 1838. In contrast, the opposite corner is occupied by the red brick and stone Grand Hotel of 1898, which itself replaced the former Blue Lion coaching inn, the Carlton Hotel and the Conservative Club. Its large ballroom was originally a cinema, the King's Hall, and was entered from Belvoir Street but, after several changes of name, it closed in 1928, possibly owing to the high cost of updating the equipment to cater for the new 'talkies'. In 1881, the corner of Rutland Street and Granby Street was the location of Leicester's first telephone exchange.

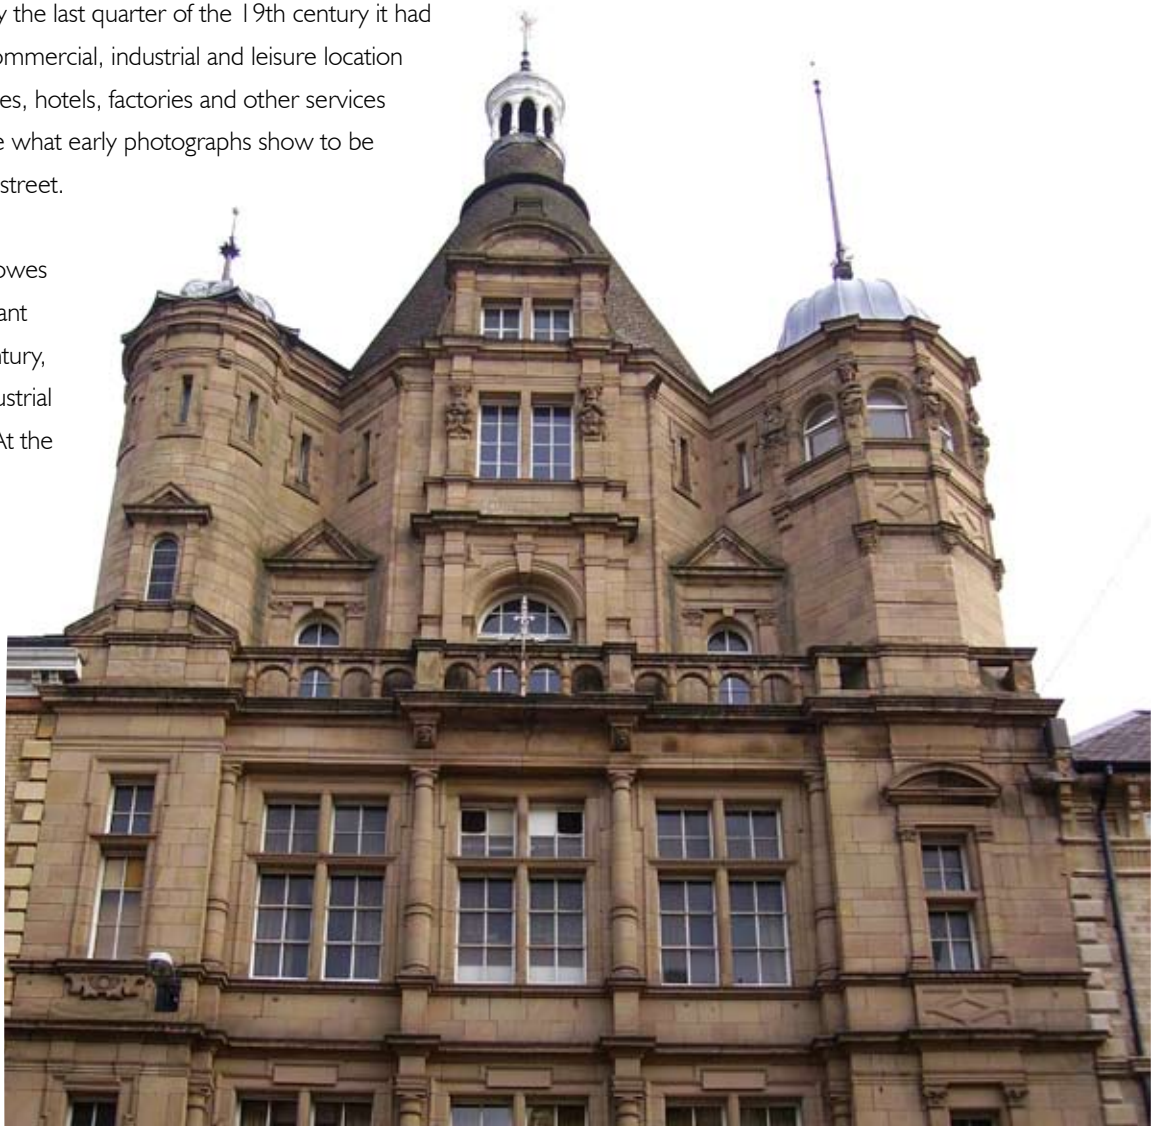
The former Victoria Coffee House at 38 & 40 Granby Street, dates from 1888 - the year of the Queen's Jubilee, and hence the name. The architect was Edward Burgess.

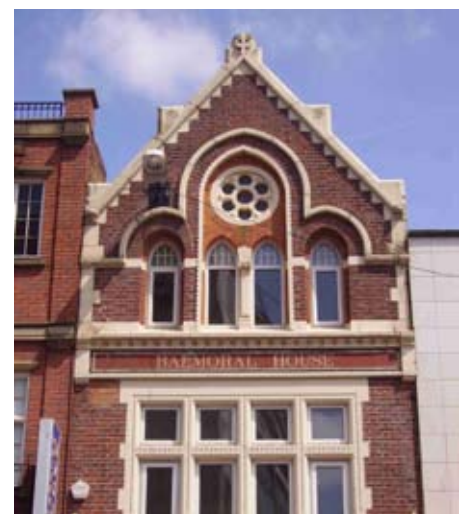
A close-up of 'Balmoral House', 88 Granby Street; it dates from 1873 and was designed by local architects Shenton and Baker

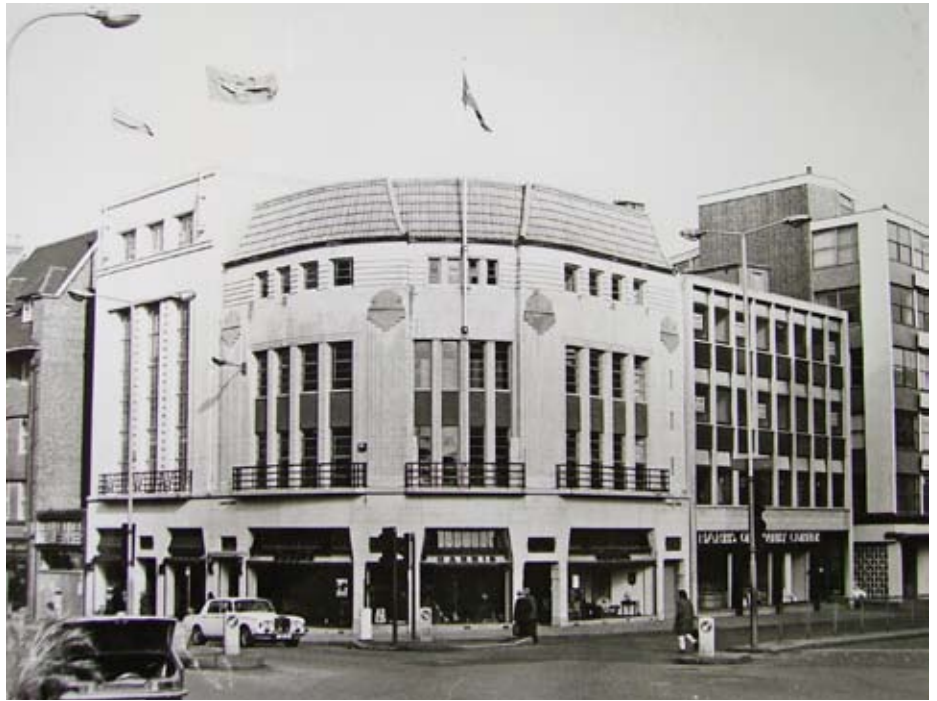
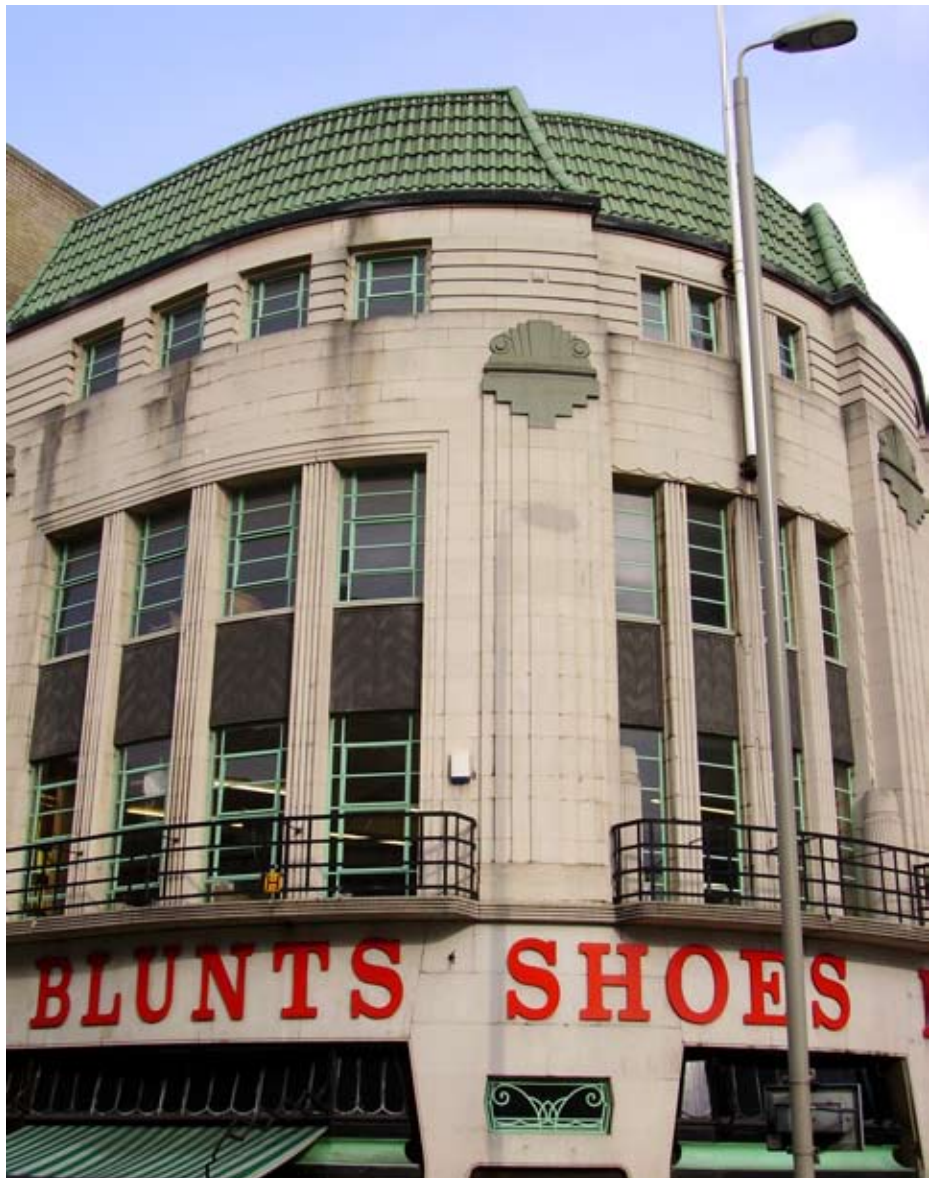
Above: Two views of the Art Deco building at 128-132 Granby Street; it was originally Harris' Furniture Store as can be seen in the top picture dating from the 1960s. The corner building is now occupied by Blunt's Shoe shop.

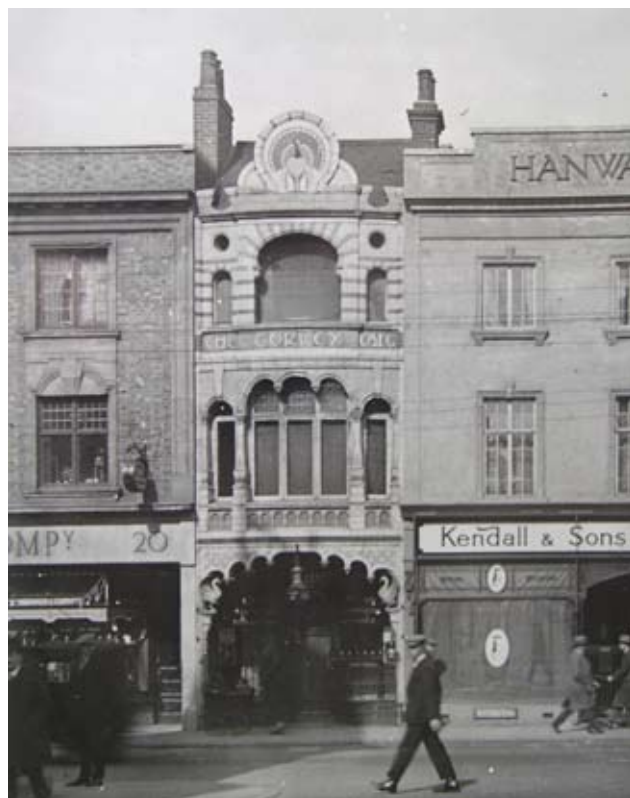
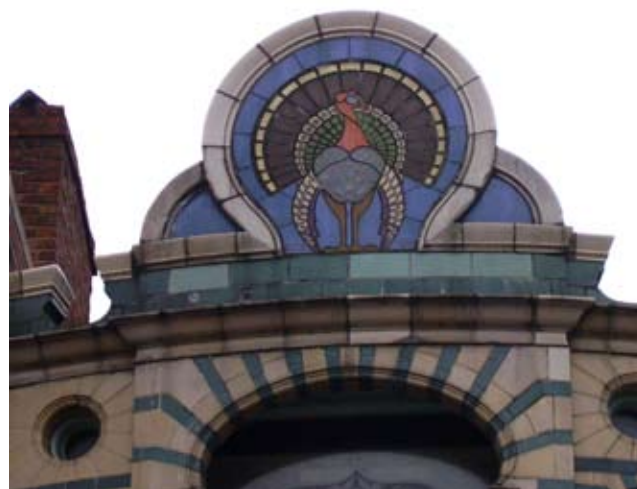
Top: A view of the Turkey Café taken in the early years of the 20th century and above: a close up of the brightly coloured tiling.

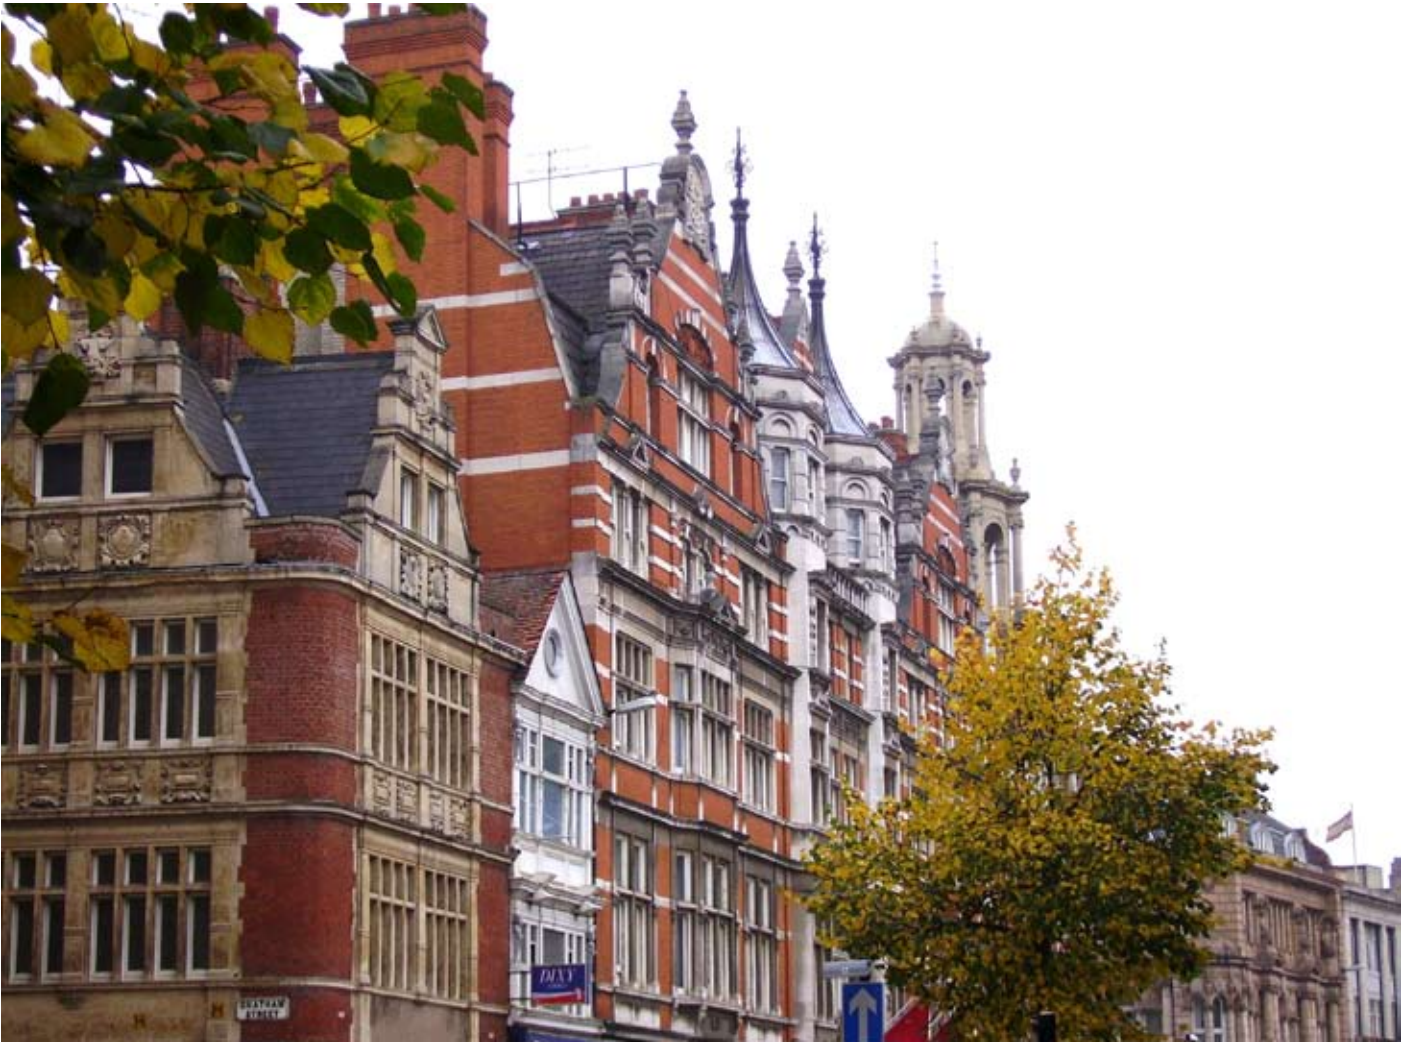
The range of architectural styles along Granby Street is exceptional. Here at the corner of Chatham Street the chosen style was Flemish, adjoining is the Grand Hotel with its varied skyline.

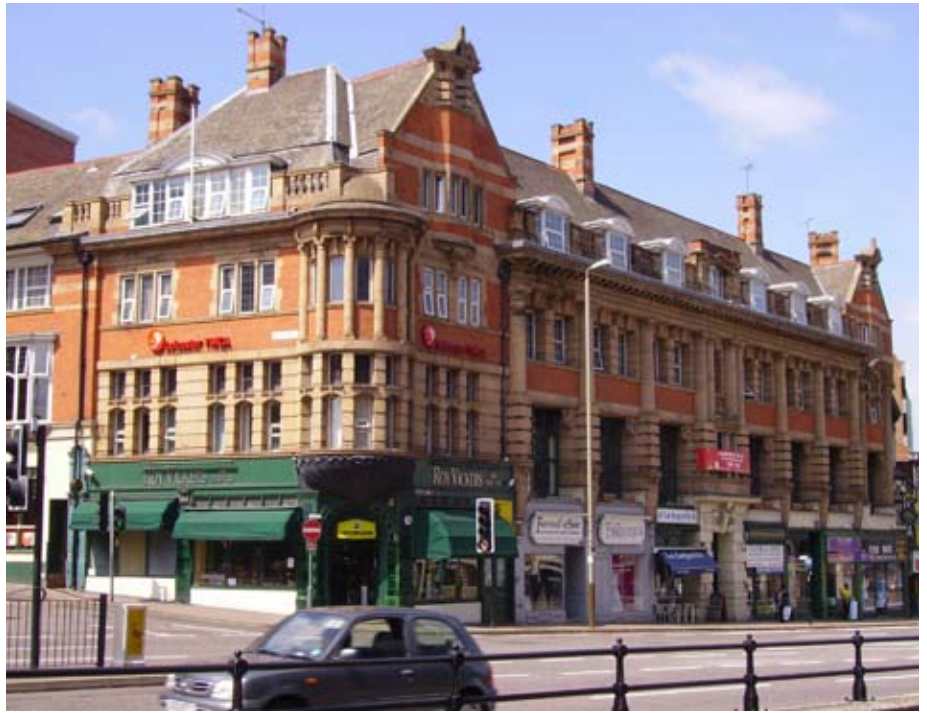
The Leicester YMCA at the corner of East Street and the building opposite, Blunts Shoes are two large contrasting buildings that frame the approach to Granby Street from London Road.

Street is framed by two large and contrasting buildings (the YMCA and 128 Granby Street), while the view further into the street is obscured until it is actually entered. The buildings at each end of Granby Street also form 'gateways', each of which creates a 'sense of arrival'. A subtle bend part way along Granby Street obscures views in both directions, inviting further exploration.

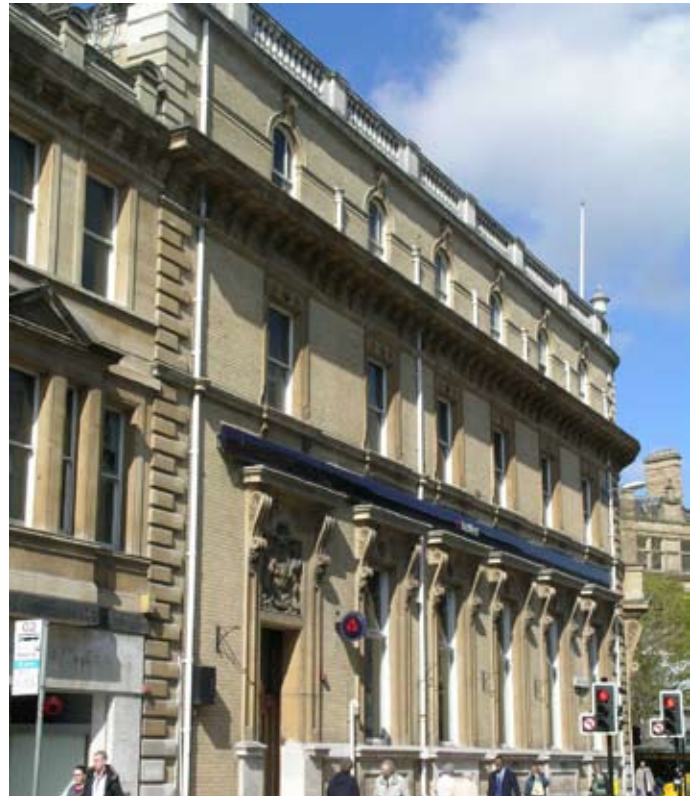
Number 1 Granby Street was designed in the classical revival style. The stone work is particularly fine with a strong horizontal rhythm created by the large stone console brackets and the stone cornices at first and second floor levels.

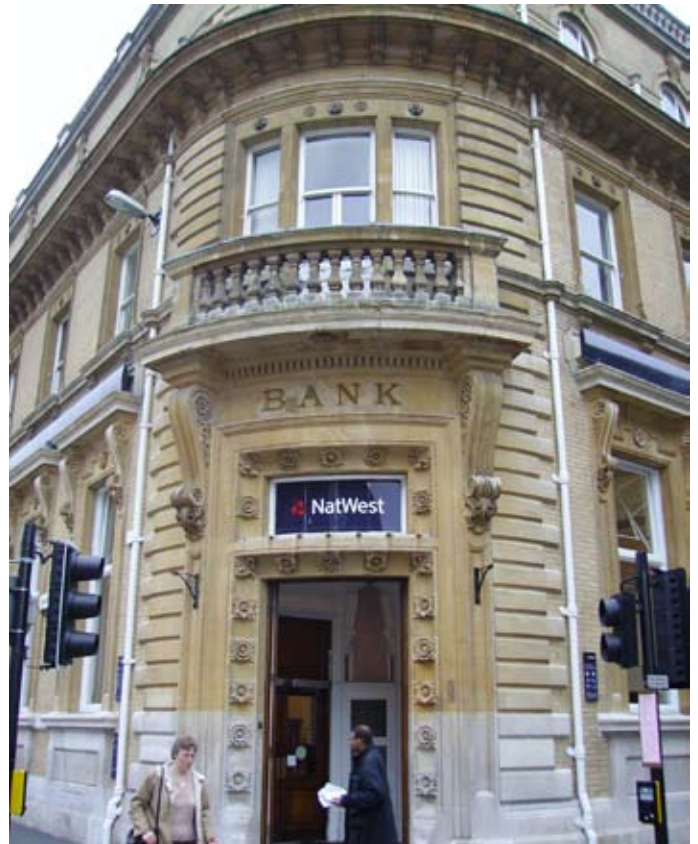
The impressive public entrance to the NatWest bank premises at the corner of Granby Street and Horsefair Street.

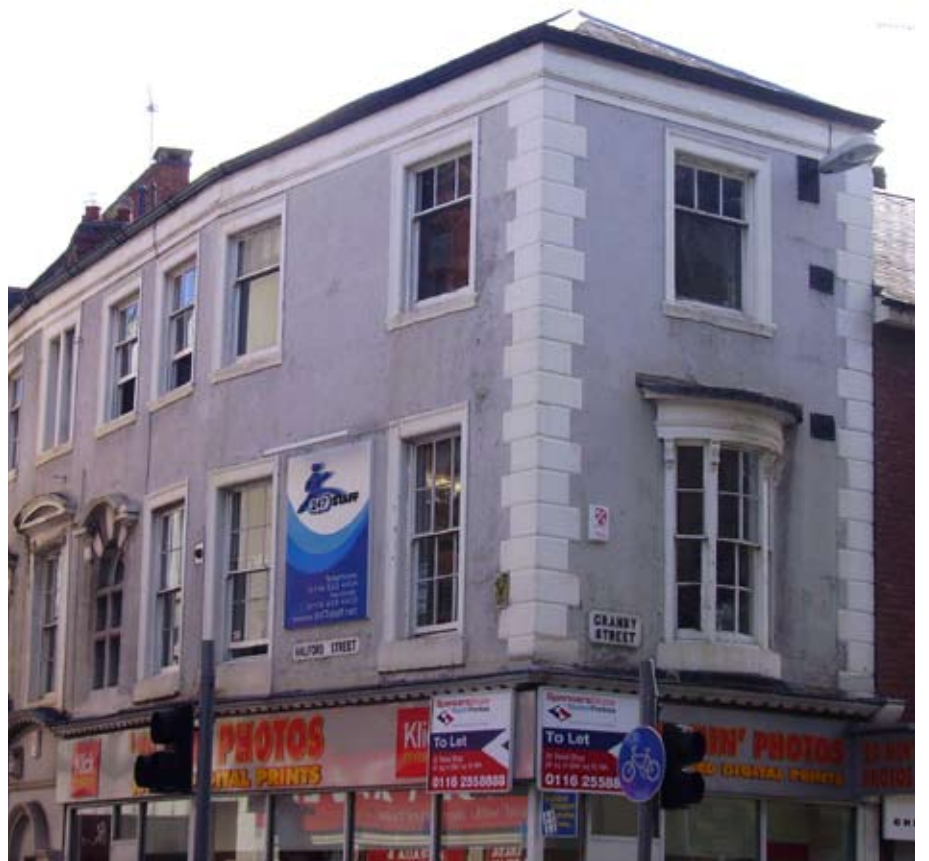
Number 2 Granby Street features a very fine oriel bow window

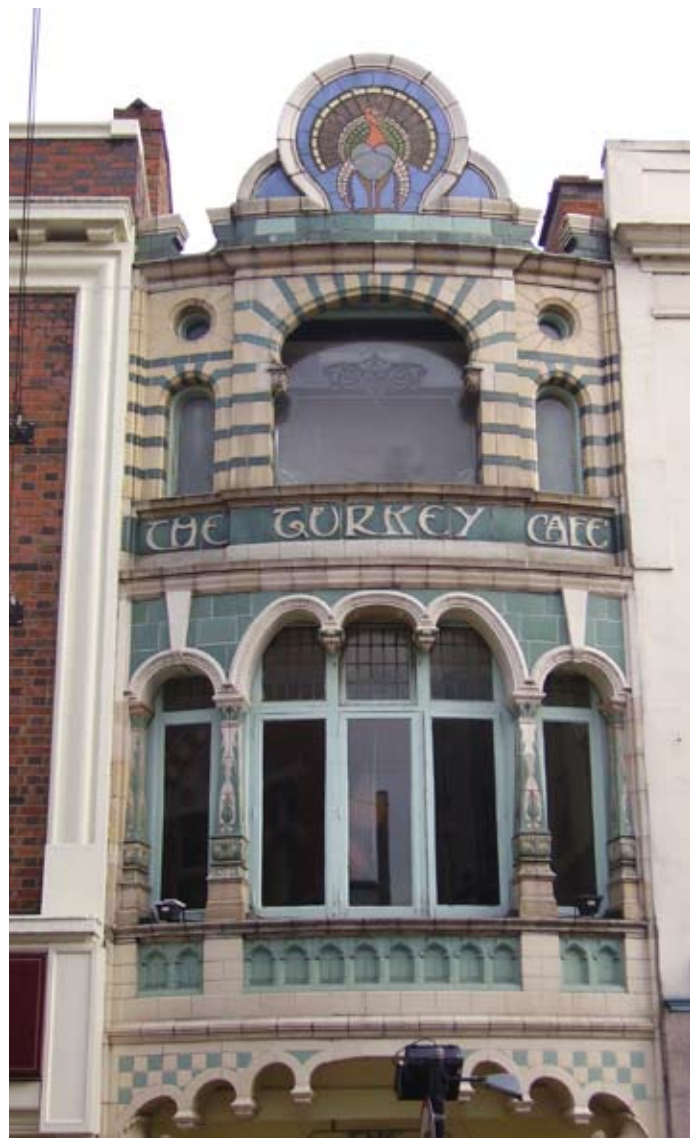
The Turkey Café was built to the designs of Arthur Wakerley in 1901. The exotic Turkish/Persian style moulded and glazed terracotta was made at the Doulton Pottery in Lambeth.

building in the conservation area, **The Turkey Café, 24 Granby Street**. The three buildings, despite their different designs, maintain strong horizontal patterns – the windows are all at the same level, as are the parapet lines, while the vertical rhythms of brick and render at 22 Granby Street contrast with and emphasise the patterns on the Turkey Café. The plain façade of 26-28 Granby Street acts as a foil for its more decorative neighbours, highlighting their architectural details. The Turkey Café itself is a Grade II listed building designed by the well known local architect, Arthur Wakerley, and built in 1901. Its cast iron frame is clad in brightly coloured matt-faced carraraware tiles by Royal Doulton. Unique in Leicester, it was restored in 1984 when the then occupiers, Rayners Opticians, commissioned Hathernware Ceramics of Loughborough to re-make and install the Moorish-style arch over the shopfront and the two turkeys on either side of the entrance.

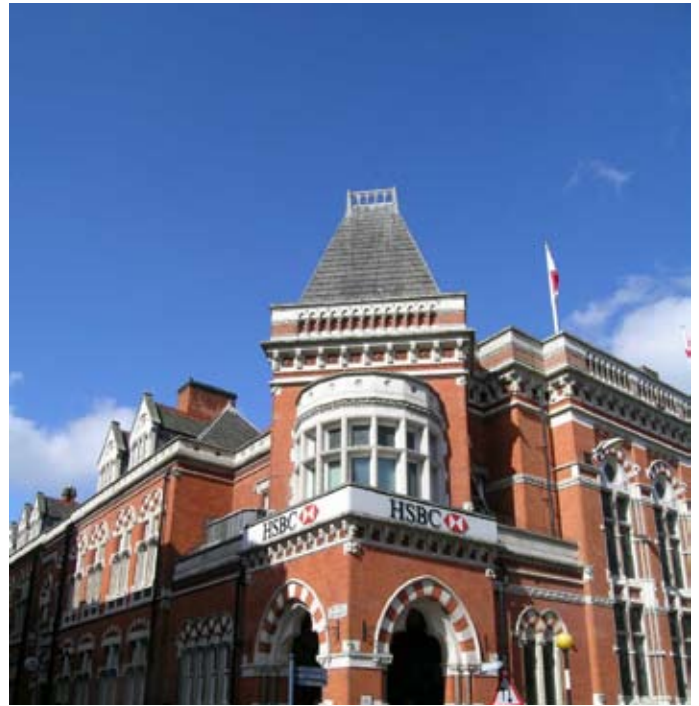
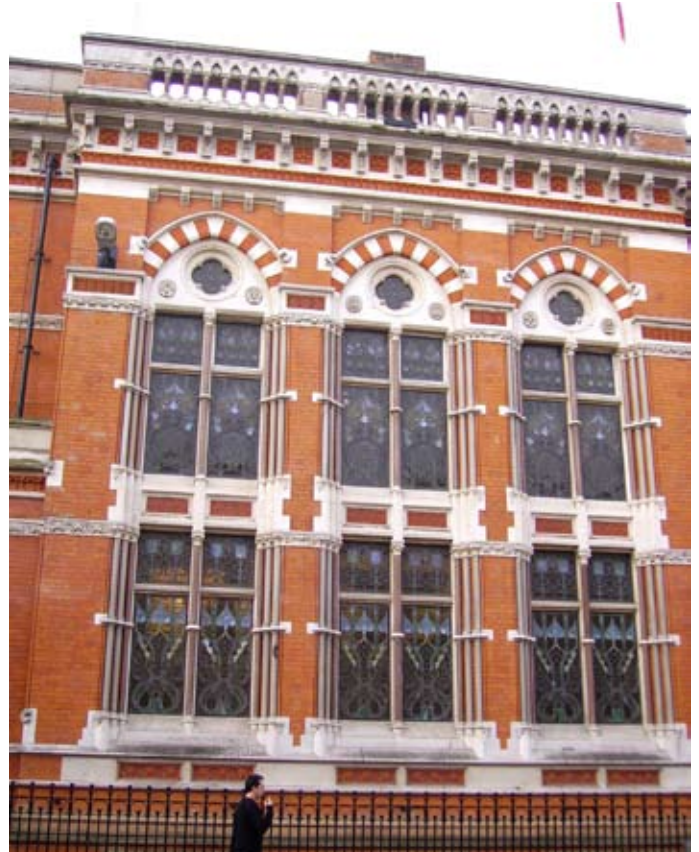
Two views of the extraordinary former banking premises at 31 Granby Street. It is listed Grade II star and dates from 1870 and was designed by the notable local architect Joseph Goddard.

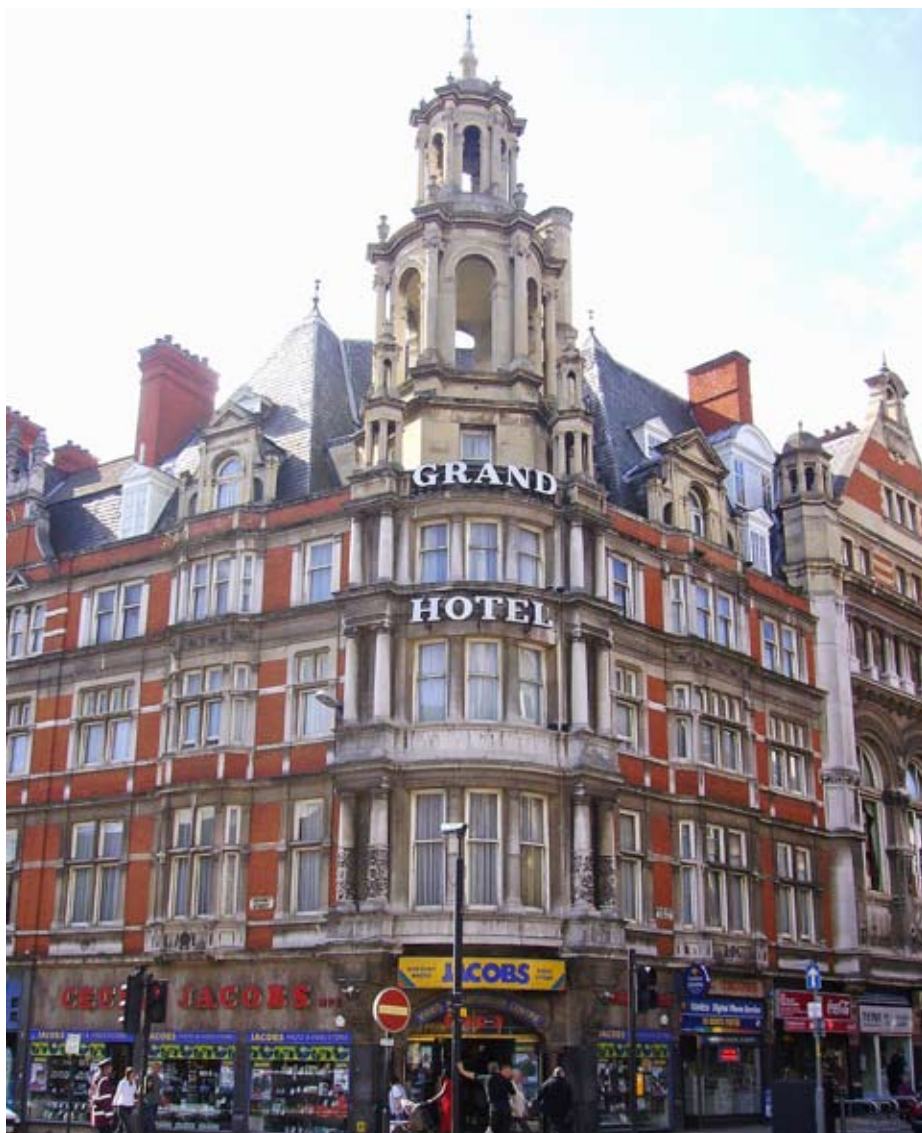
Granby Street/Belvoir Street corner is dominated by the tower of the Ramada Jarvis Grand Hotel. The architects may have been inspired by the churches of Sir Christopher Wren.

rusticated curve with a segment of a dome at second floor level. The **Ramada Jarvis Grand Hotel, 61-79 Granby Street and 2-14 Belvoir Street**, on the south corner again marks the junction with a curved façade but adds paired columns to each floor surmounted by a two-stage stone domed cupola. The east corner is the plainest building but it too acknowledges the importance of the junction with a splayed corner and simple geometric decoration.

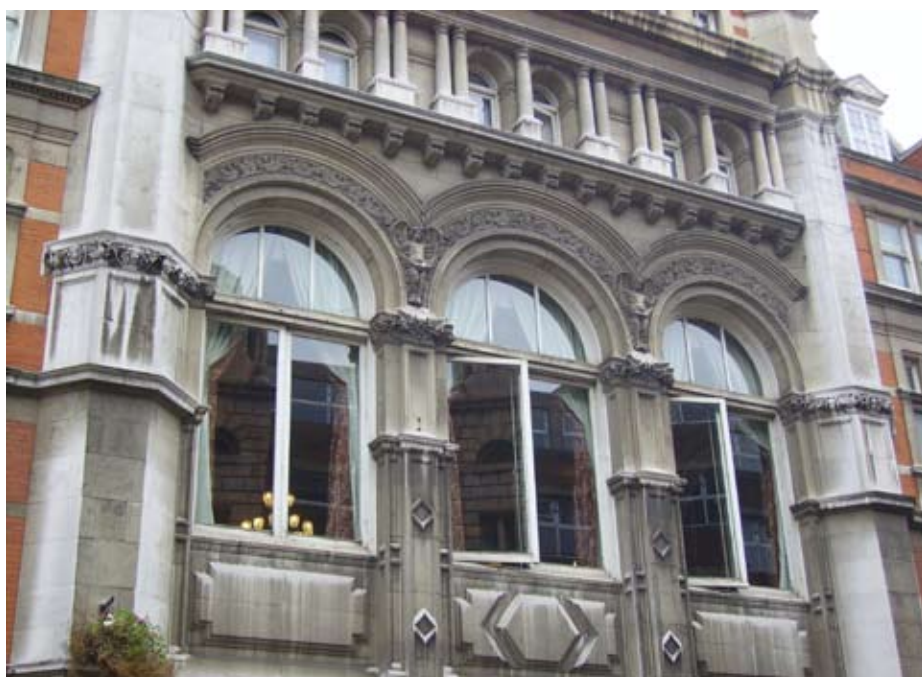
Part of the Belvoir Street elevation of the Ramada Jarvis Grand Hotel showing the three round-arched windows to the first floor ballroom/function room.

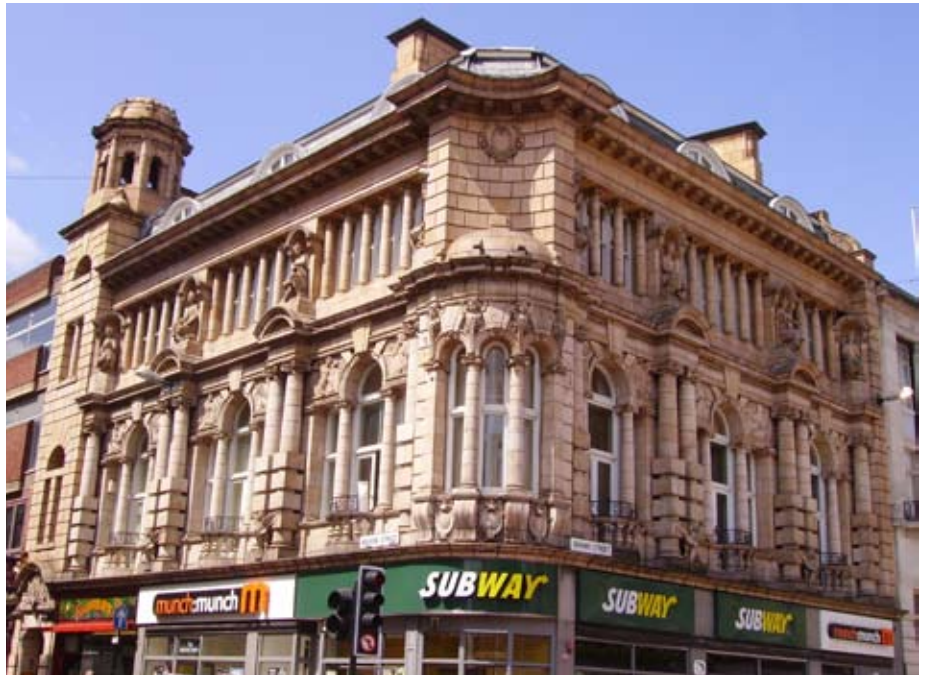
At the corner of Granby Street/Belvoir Street the former General Newsroom was designed in the Baroque style - a popular choice of architecture for large public buildings at the end of the 19th century.

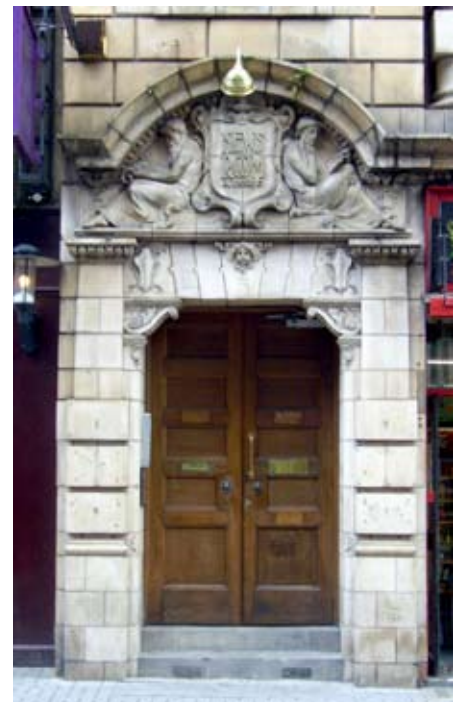
Detail of entrance to former General Newsroom, Belvoir Street.

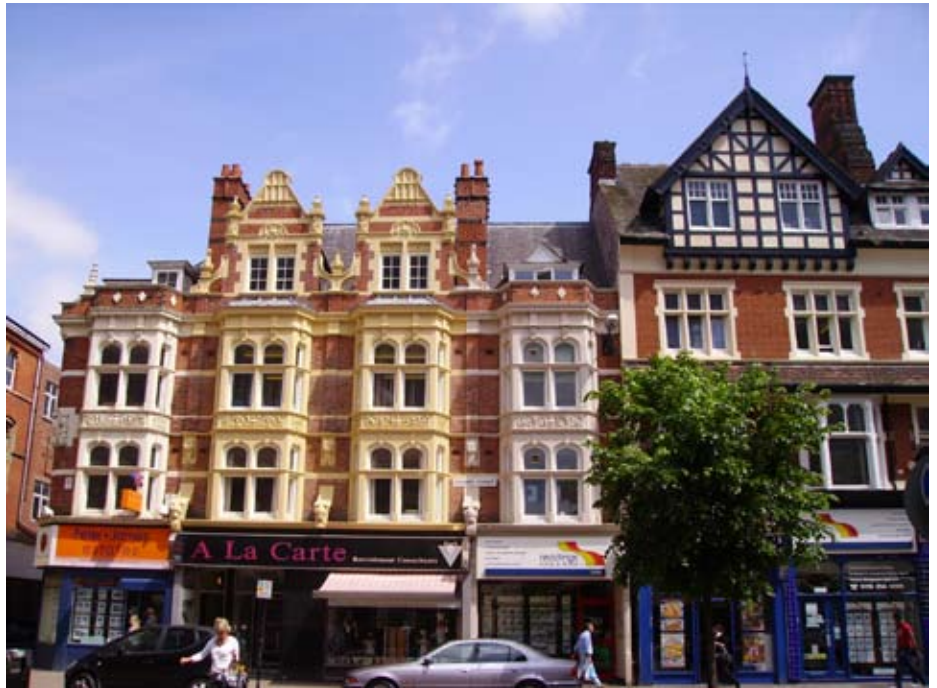
Numbers 76-82 Granby Street at the corner of Alfred Place combines a range of architectural styles and features a series of decorative carved brackets supporting the stone fascia.

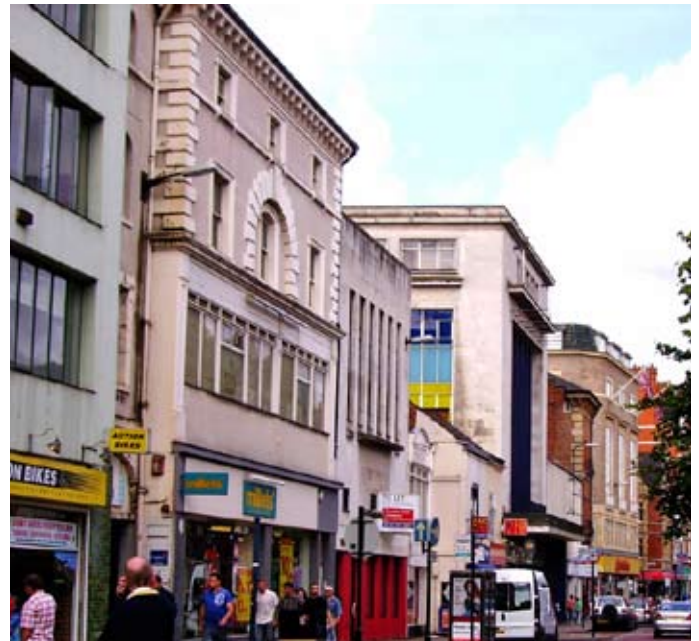
Only the upper, top two floors of Thomas Cook's Temperance Hotel at 123 Granby Street remain intact. Both the shopfront and first floors having been altered drastically. Beyond can be seen the large Portland stone building that was originally the Maples furniture store, built in the 1950s.

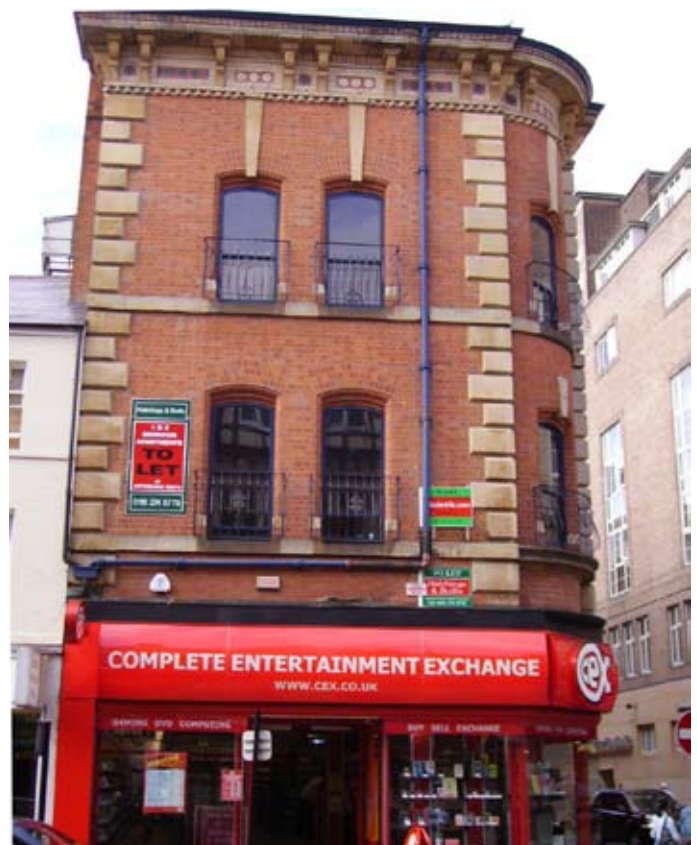
Number 97 Granby Street dates from the last quarter of the 19th century.

4.45 The three buildings at **97-107 Granby Street** are an interesting mix of 19th and 20th century building types. The first, 97 Granby Street, is a small Victorian factory building from the last quarter of the 19th century. Its builders have used simple architectural details to emphasise its presence in the street such rusticated stone quoins at each end and on either side of the curved corner to York Street. Two plain stone bands run horizontally across the façades and the window openings have segmental gauged brick arches above and round-edged bricks on either side. Decorative elongated stone keyblocks have been added above the second floor windows, linking up to a projecting eaves cornice decorated with pale yellow/white dog-tooth bricks, clay tiles and paired moulded stone brackets. The adjoining property probably dates from the middle of the 19th century. It would have been a shop with living accommodation in the upper two storeys, and is therefore built to a domestic scale with lower floor heights and smaller windows than its neighbour to the north. Few original building features remain, other than the right hand sash windows.

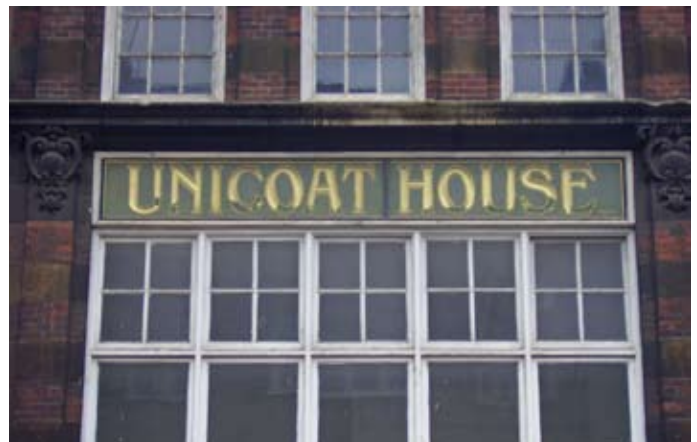
Detail of 151 Granby Street showing the original decorative sign above the first floor windows. The building is designed in the Arts and Crafts style and dates from the 1900s.

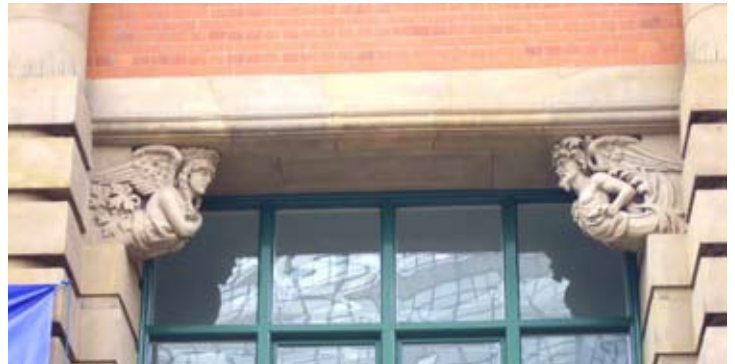
YMCA, detail of winged figures at first floor level.

4.51 The last building in the conservation area is the Grade II listed late (1898-1901) Victorian Baroque **YMCA** that occupies the plot **1-7 East Street & 161-179 Granby Street**. This very large brick and Ketton stone building is a key landmark at the entrance to Granby Street and, with the Art Deco building opposite, creates an impressive gateway into the city centre proper. With purpose-built shops on the ground floor the building has two quite different facades. The Granby Street elevation, as the most important, is on a somewhat monumental scale, having a first floor clad in stone and nine giant stone columns dividing the facade into bays. There are gables, balustrades, dormers, ornamental chimney stacks, steeply pitched stone slate roofs, keystones and sculptures representing, among other things, Architecture, Sculpture and, possibly, the Continents. The building curves round into East Street and the corner is decorated with more columns, a shell-like feature over the door and the original dark green glazed tiles to the shopfront. The East Street façade has less decoration but nevertheless contains two large ground floor windows with decorative transoms, two oriel windows above and matching dormers at roof level. Unfortunately, the original windows have all been replaced in plastic.

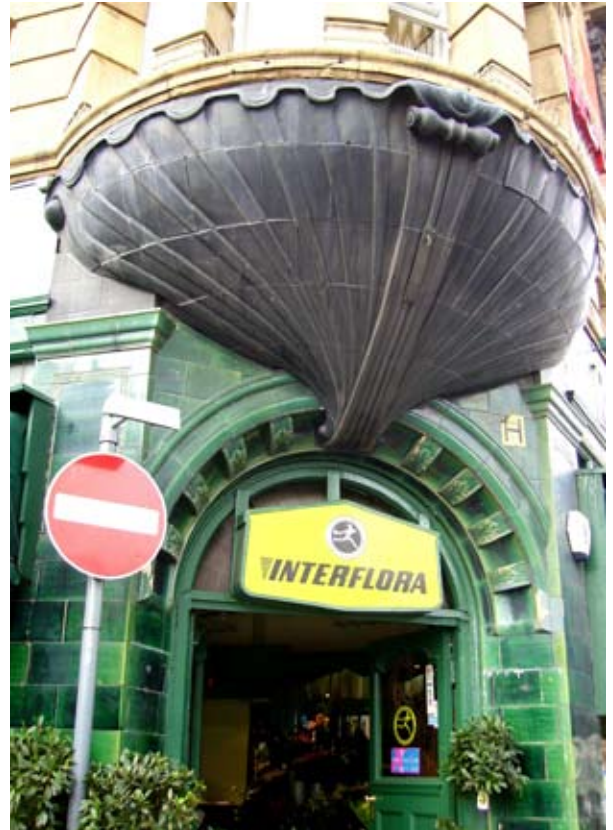
179 Granby Street, (part of YMCA). East Street corner of building showing entrance detail in green glazed tiles.

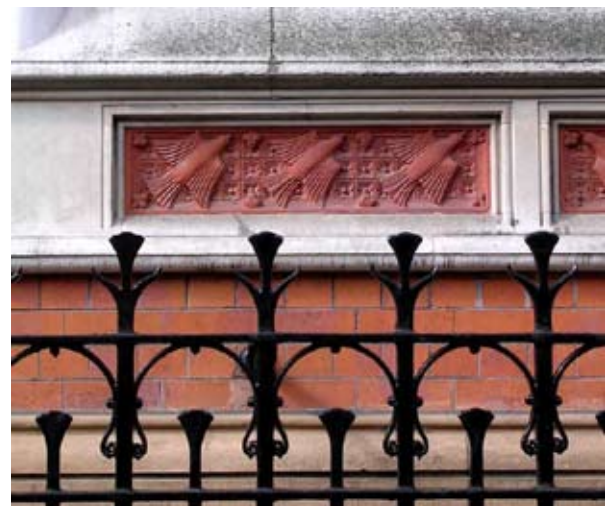
A detail of the moulded terracotta bird shapes and decorative ironwork to 31 Granby Street.

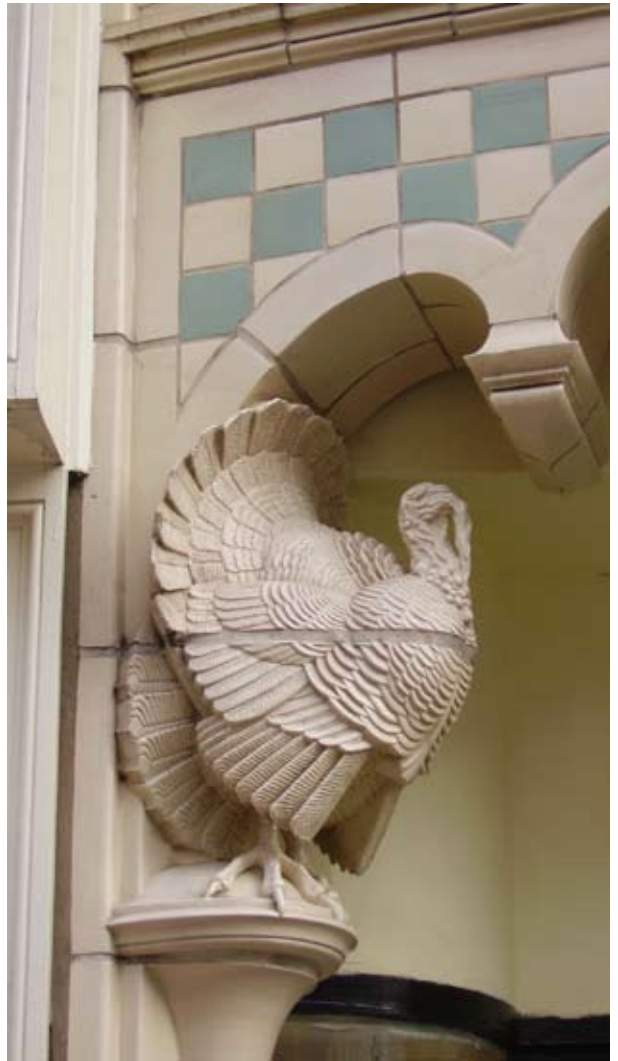
One of the two replacement "Turkeys" produced by Hathernware Ceramics of Loughborough for the 1984 restoration of the Turkey Café.

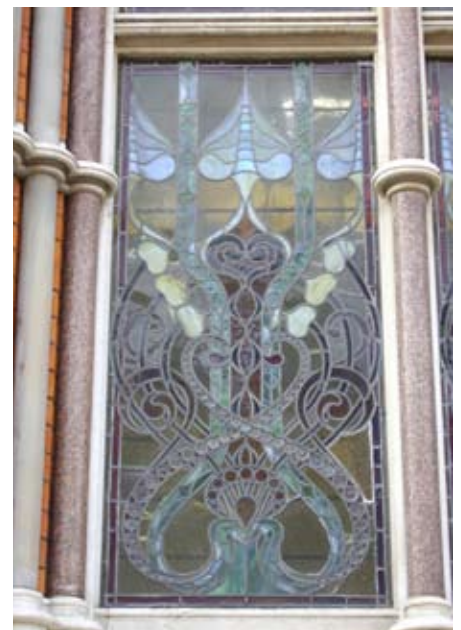
Window detail showing the flowing forms and fine coloured glass at the former bank premises, 31 Granby Street,

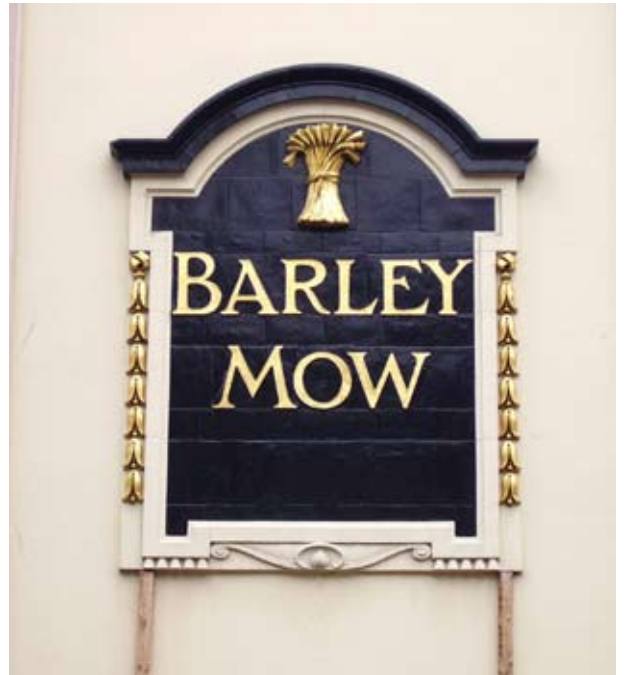
One of the two moulded and painted signs to the Barley Mow Public House at 149 Granby Street.

4.49 Neither the name, the **Barley Mow (149 Granby Street)**, nor the present appearance of the building, date from the establishment of this use on this site. In the 1850s it was the Nag's Head and its three storeys, as was common on Granby Street at that time, had a more domestic scale and appearance. By 1886 it had become The Barley Mow but the present façades probably date from the first quarter of the 20th century – a sort of neo-classical style with a stuccoed and painted finish with long quoins down the corners, moulded window surrounds and two eye-catching moulded, painted and gilded name plaques to the front and side elevations. From the Barley Mow, the buildings step up in height to the tall three storeys of 151-159 Granby Street. **Unicoat House, 151 Granby Street**, is an early 20th century building in an Arts and Crafts style in red brick with its original tall, narrow sash windows at second floor level and a finely lettered name sign in glass over the first floor windows. The building is decorated with stone bands, square pilasters, a moulded stone sill below the second floor windows and decorative cartouches in place of capitals on the pilasters at first floor level. The original shopfront fascia brackets and decoration remain in situ but the modern shop fascia below is overly deep and out of scale. On a similar scale and with a full width first floor window **153 Granby Street** retains its original splayed shopfront and is crowned by a tall gently curved parapet.

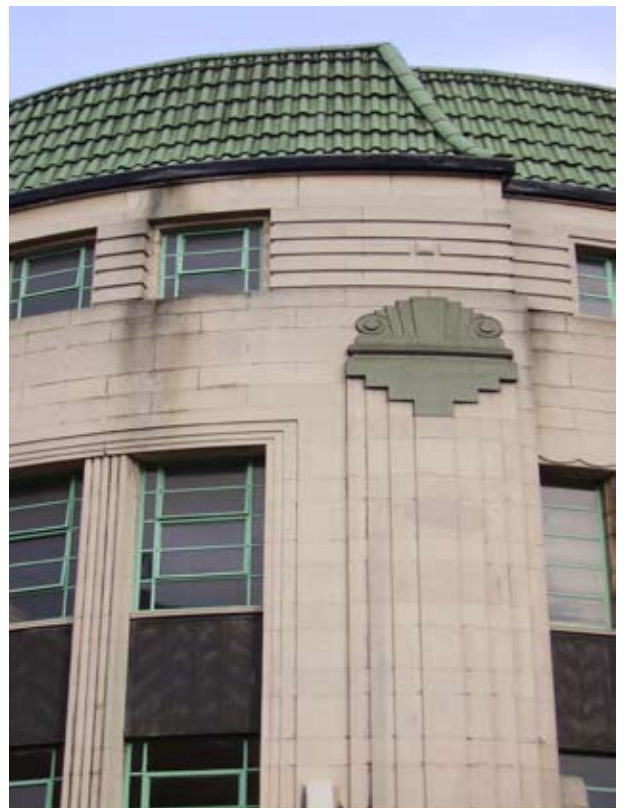
Green glazed tiles, Portland stonework, bronze panels and steel window frames are used to great effect at 128 - 132 Granby Street.

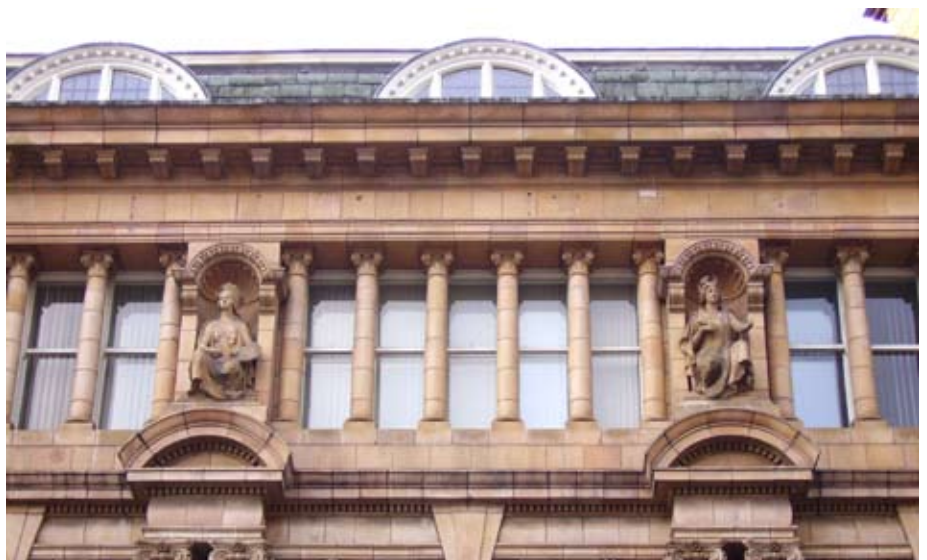
Part of the former General Newsroom designed by Joseph Goddard and dating from 1898. This replaced William Flint's building of 1838, (see page 28).

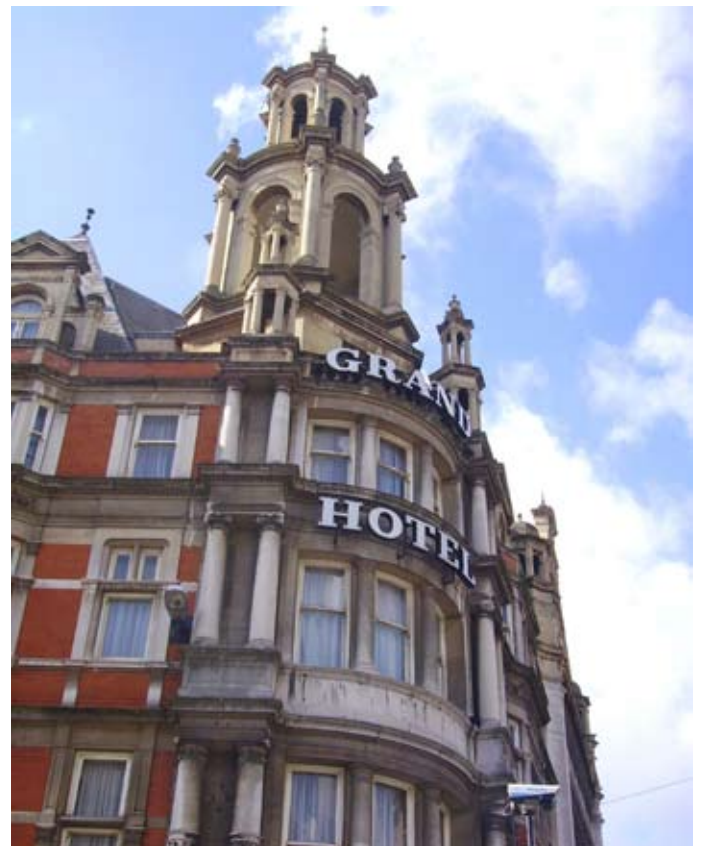
Detail of the stone cupola to the Ramada Jarvis Grand Hotel.
